PRELIMINARY DATA REPORT
BRENTON REEF
WELLFLEET
NORWALK
DISPOSAL SITES
AUGUST 1981

CONTRACT #
DACW33-81-C-0115

New England Division
U.S. Army Corps of Engineers
424 Trapelo Rd.
Waltham, MA 02154

The purpose of this report is to document the sampling procedures used during these surveys and to present preliminary results of these measurements.

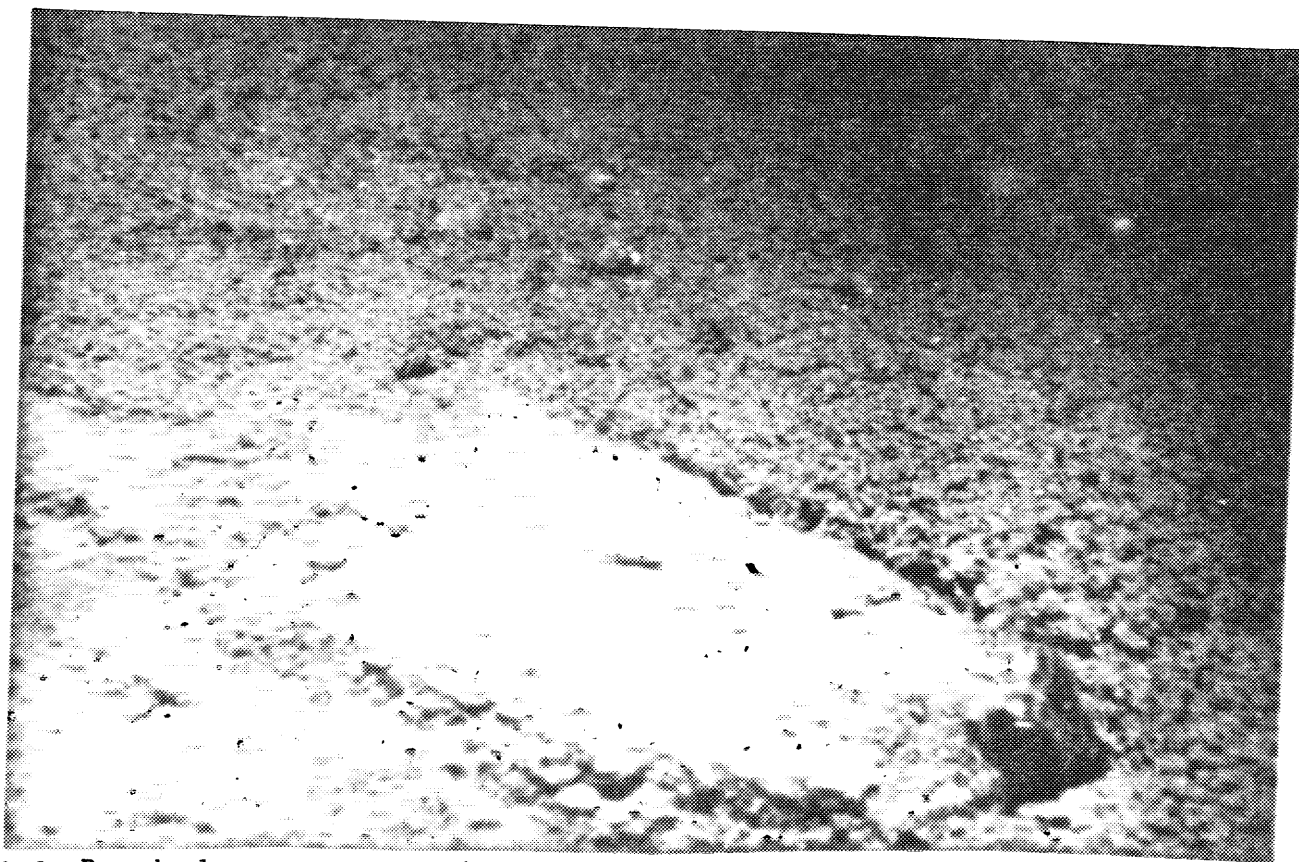
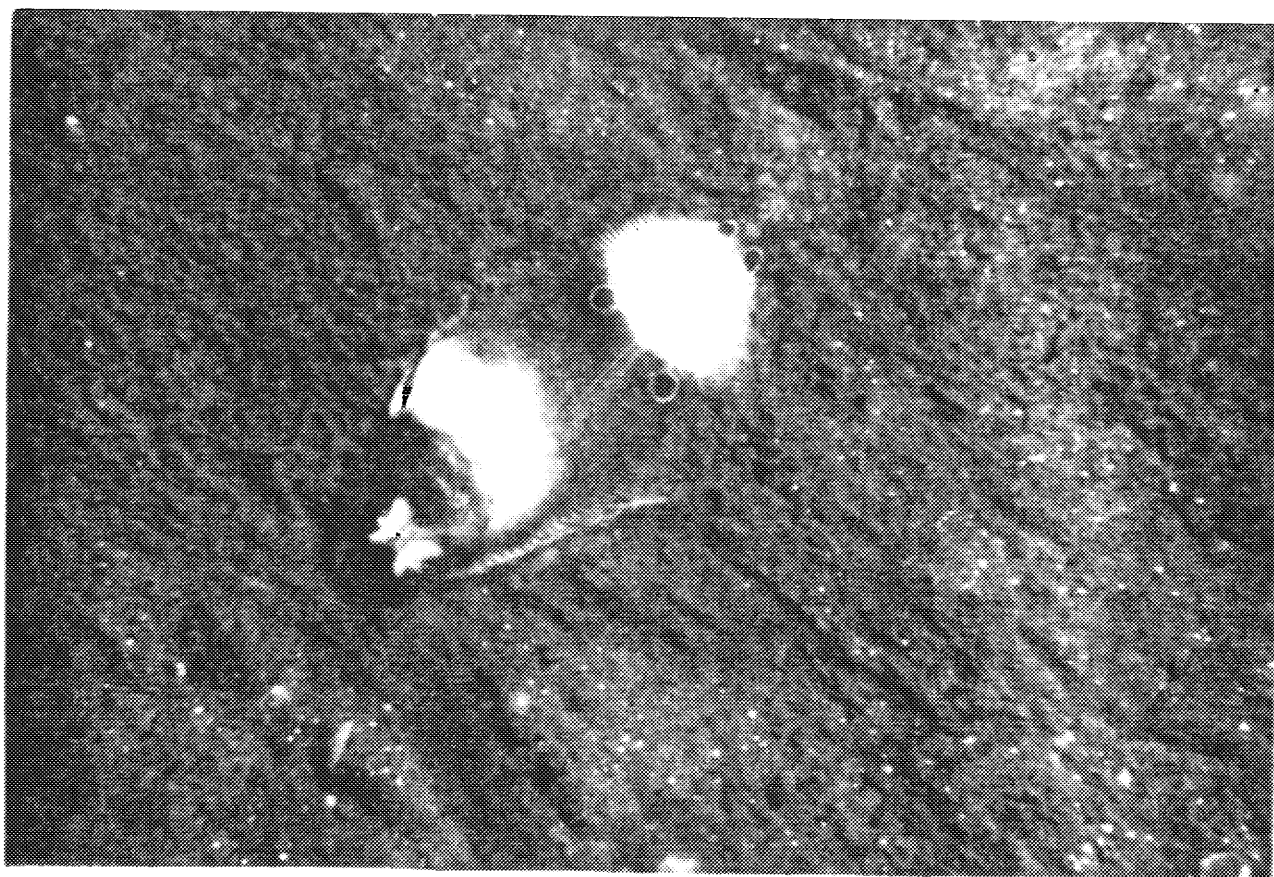
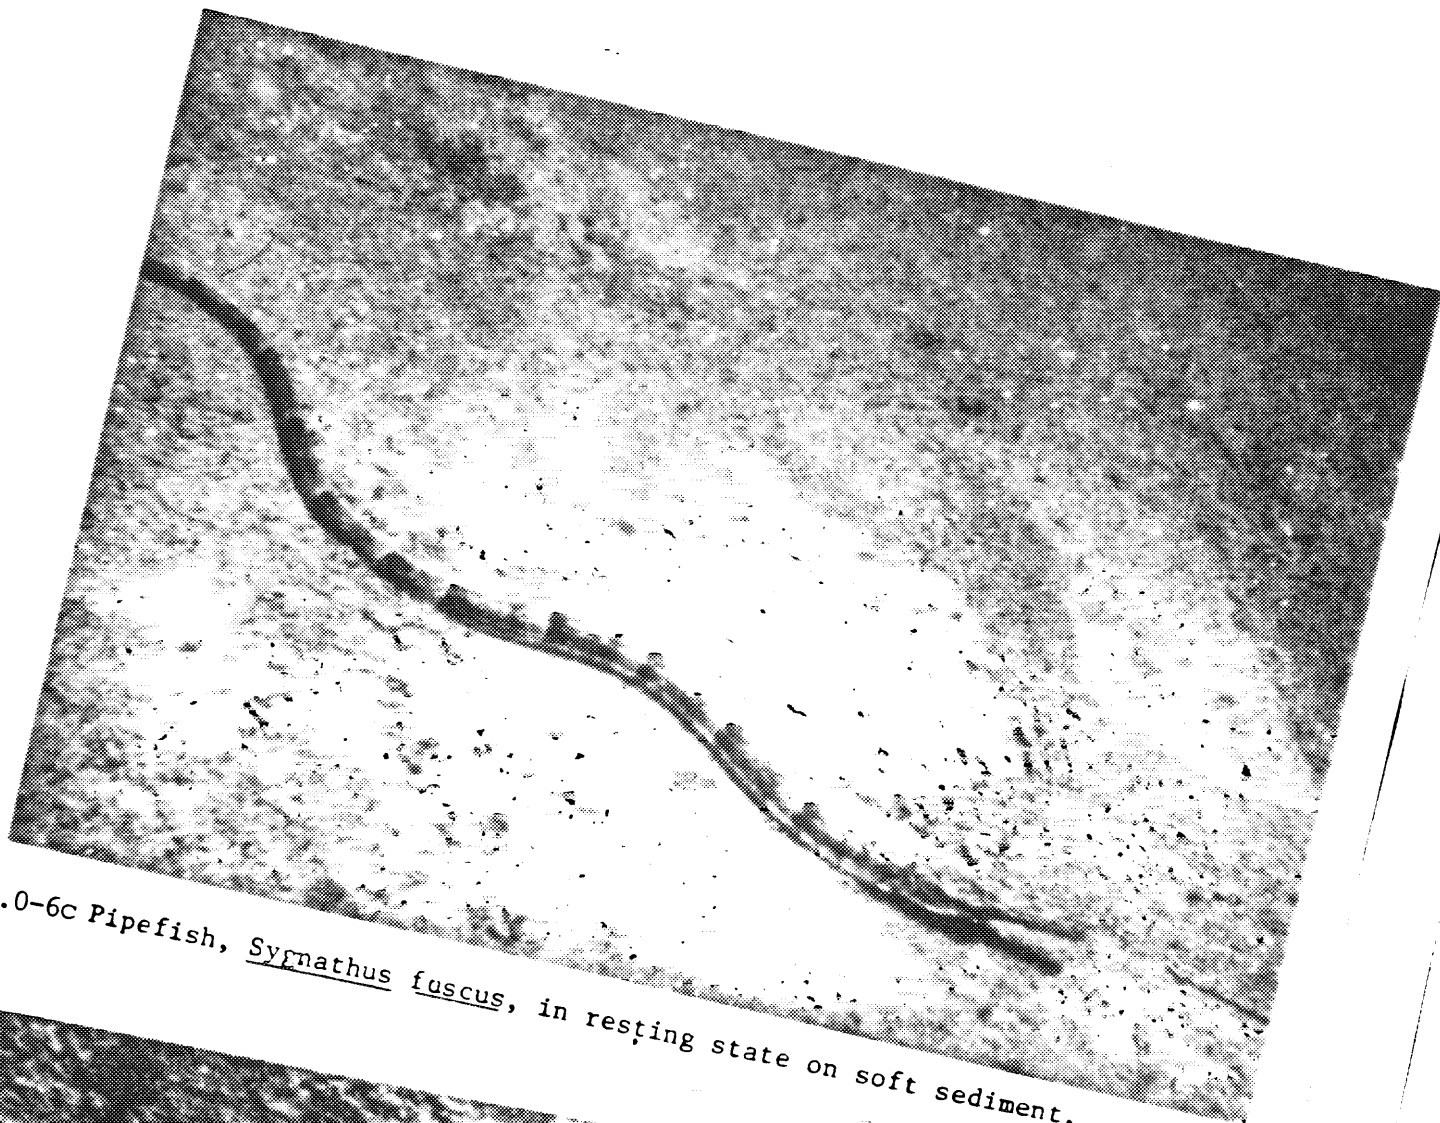
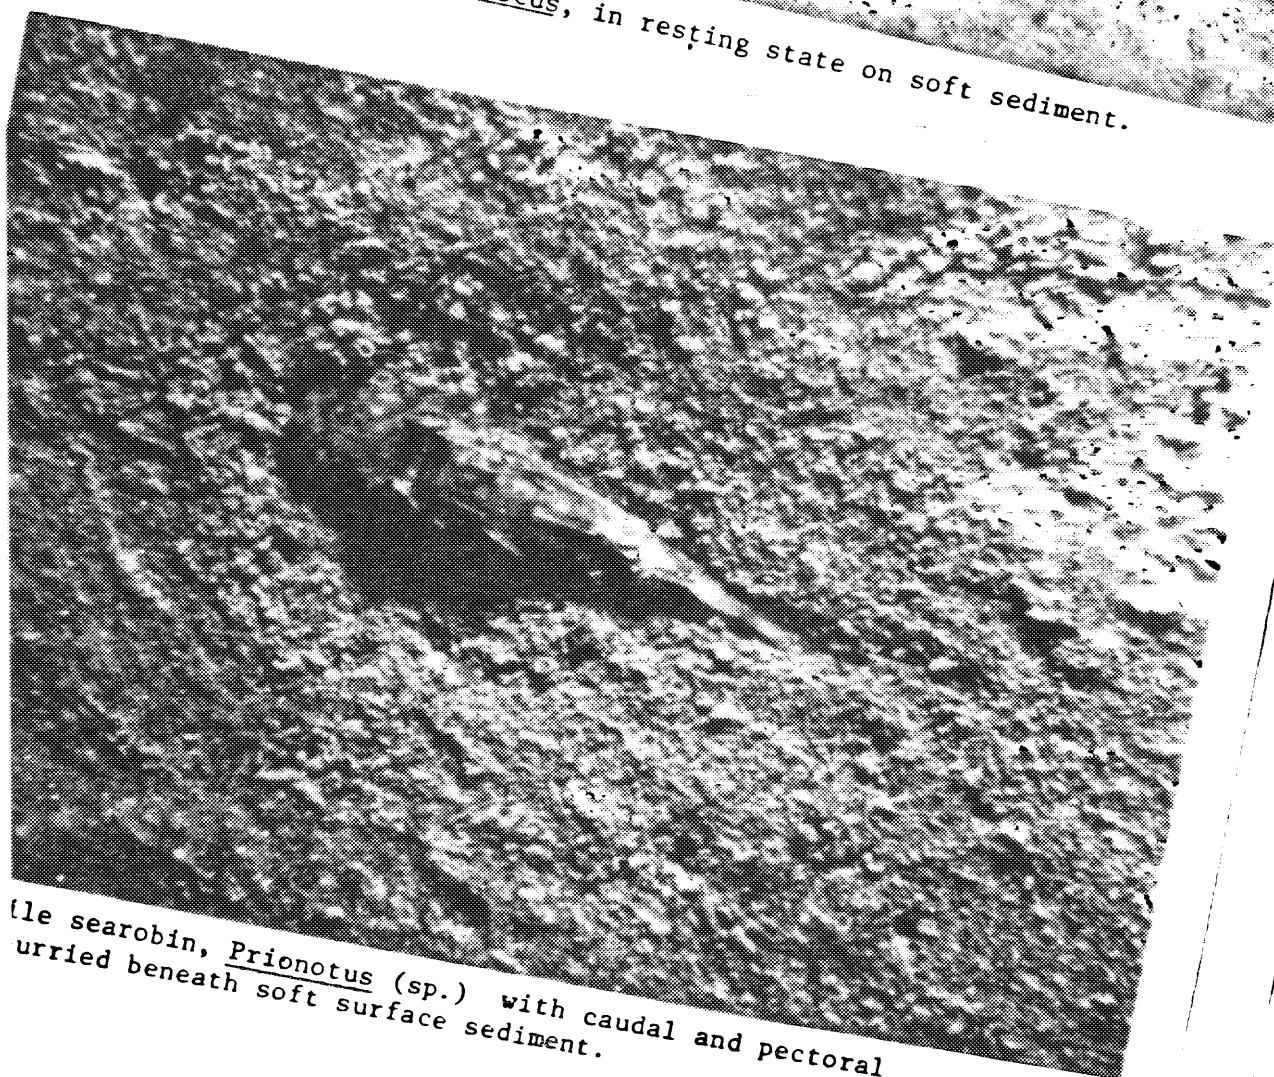
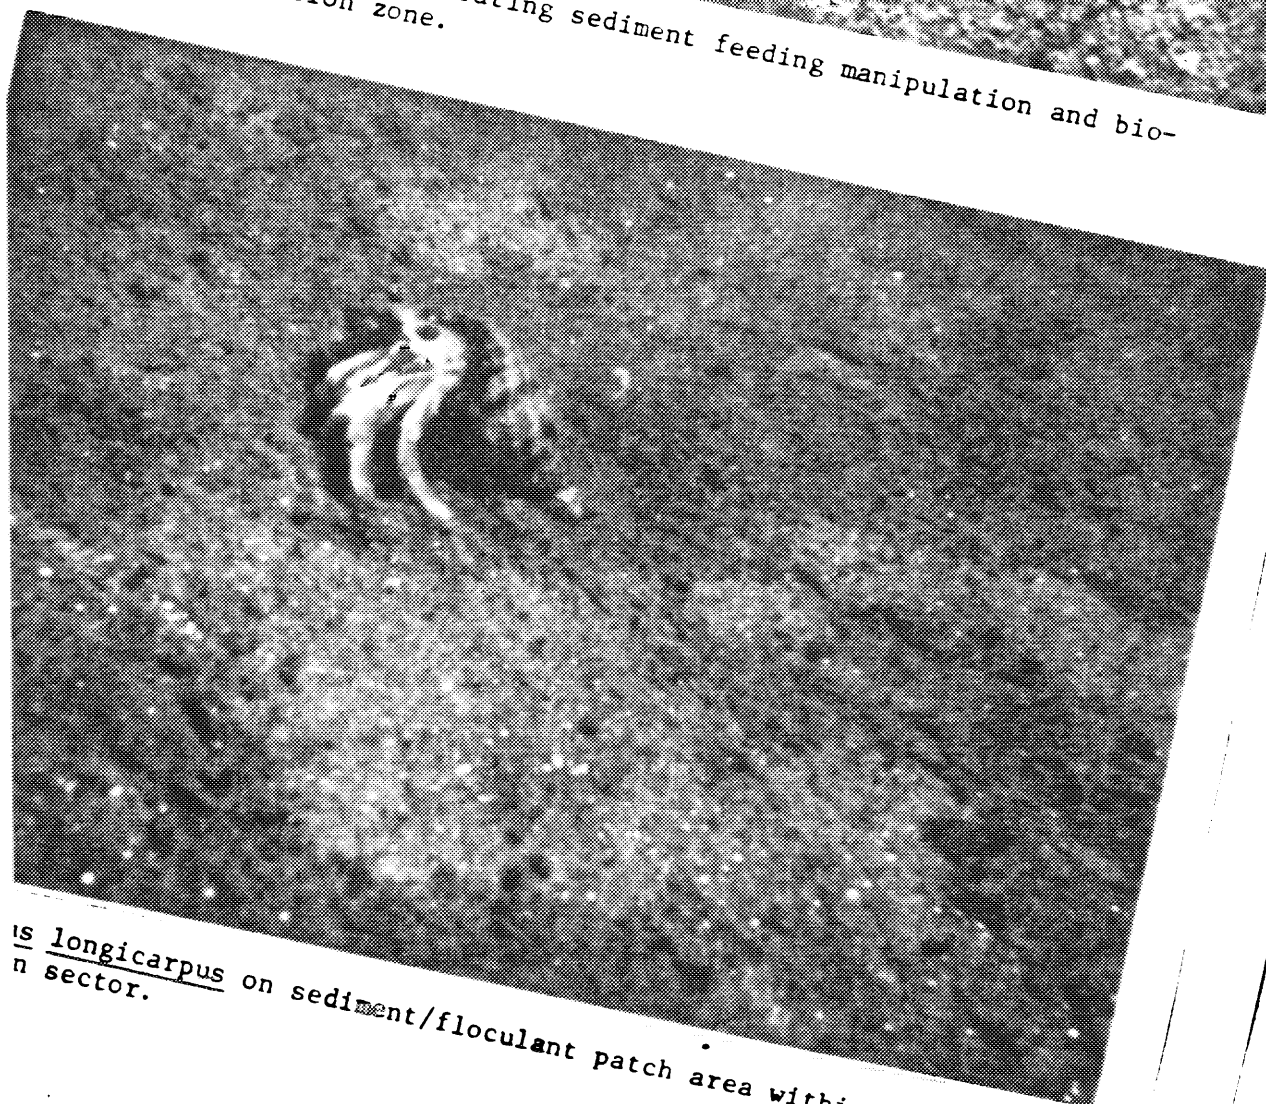
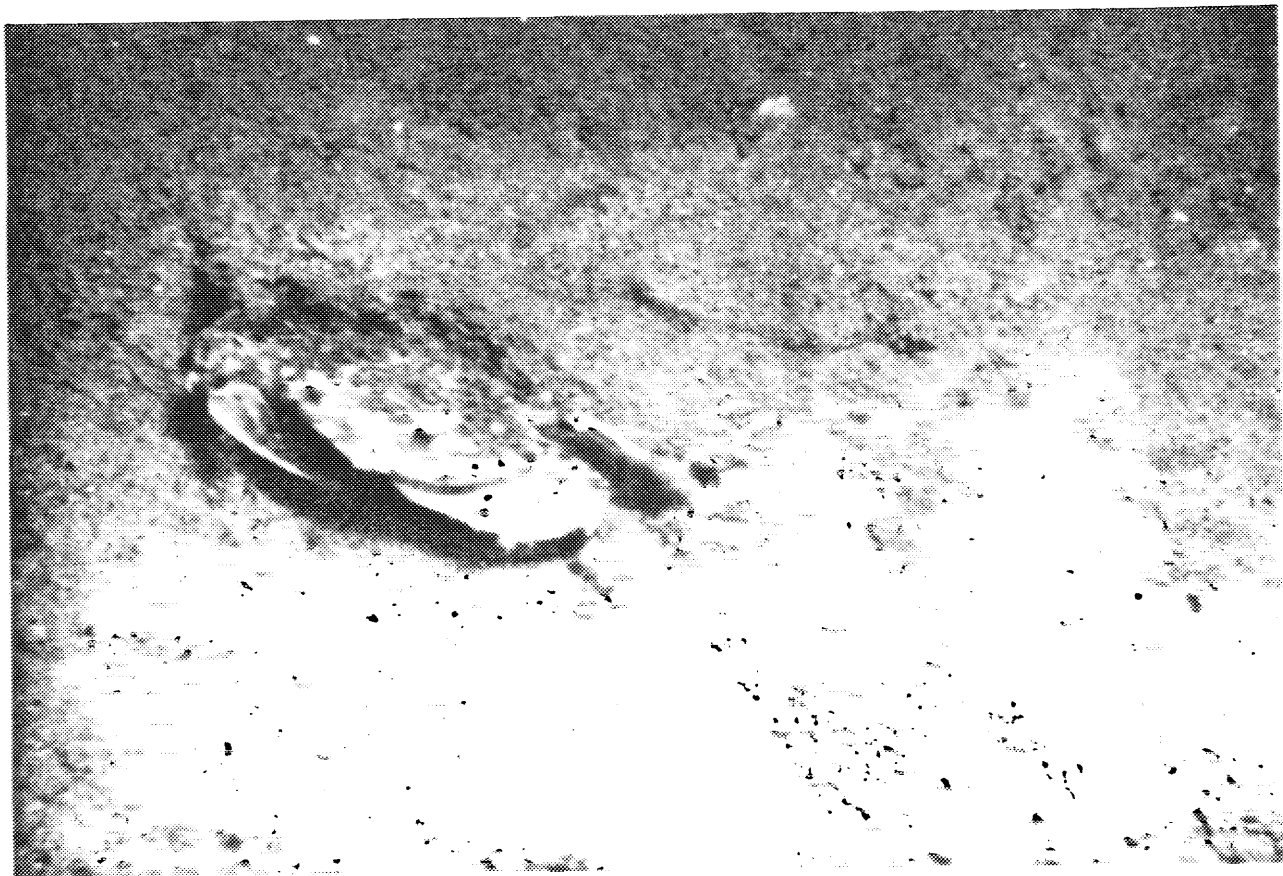
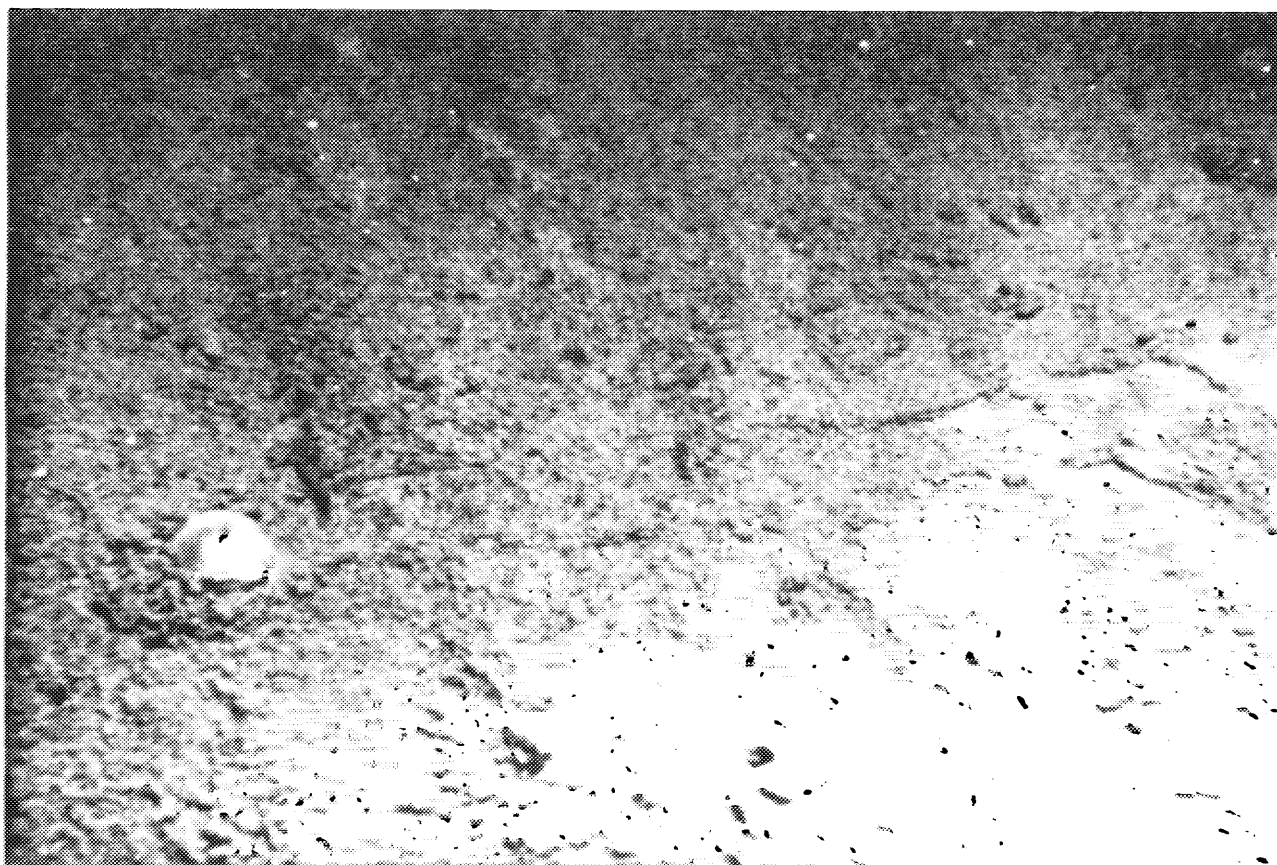
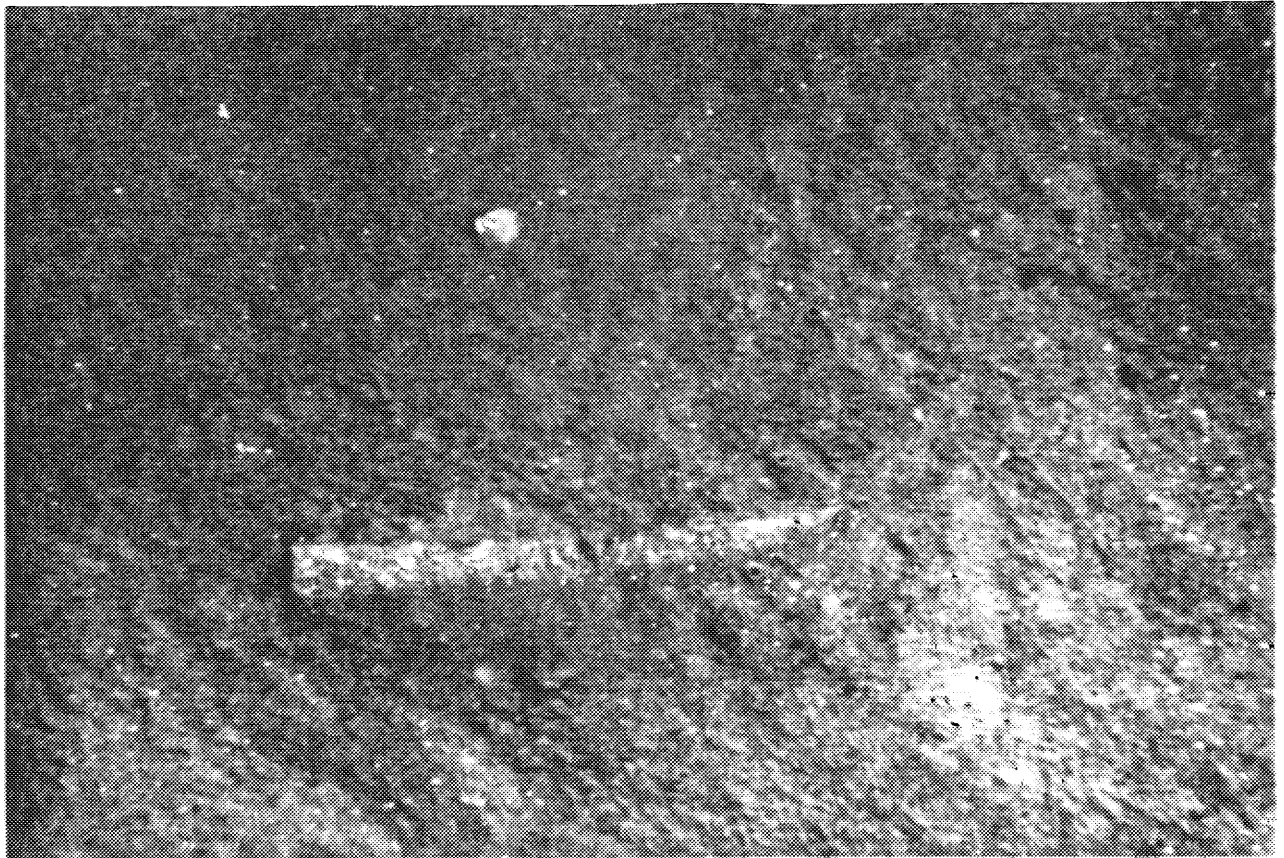
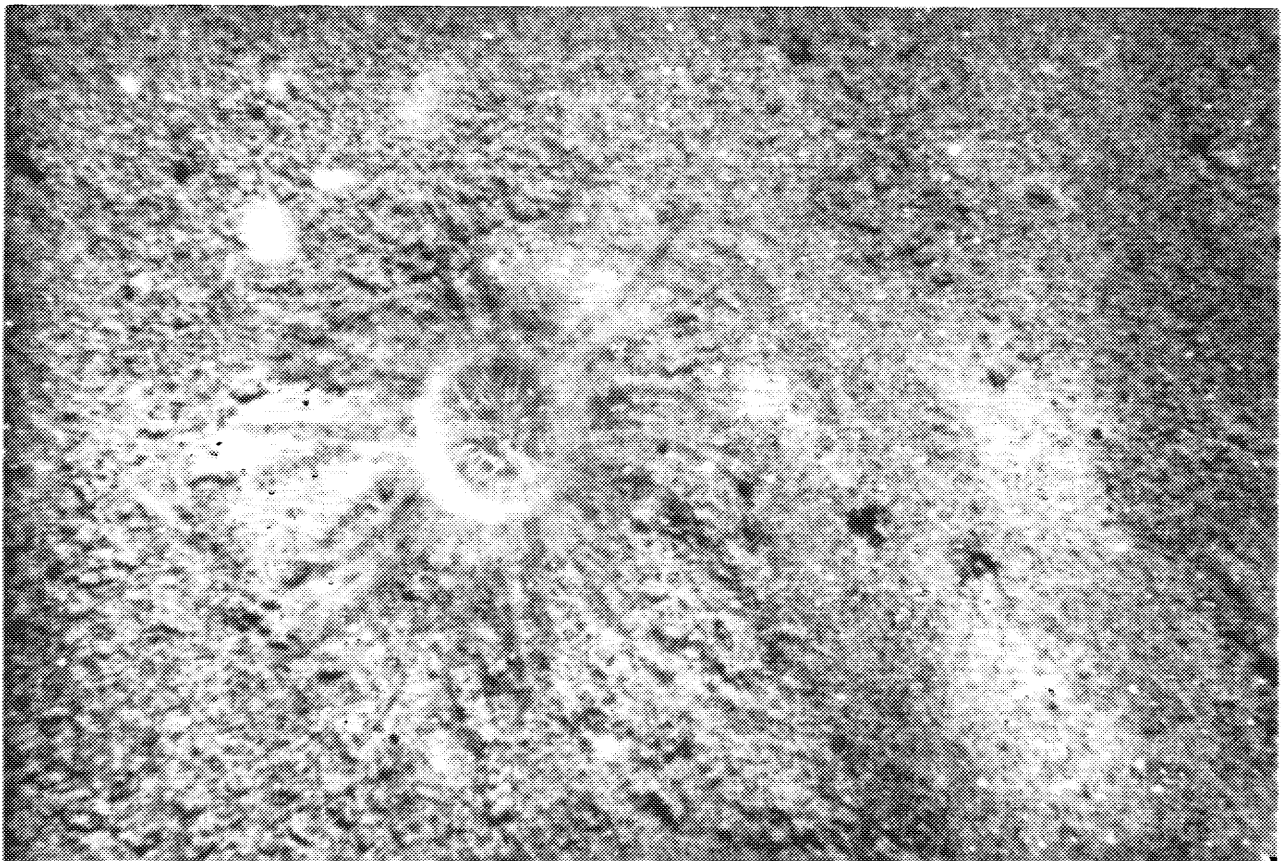
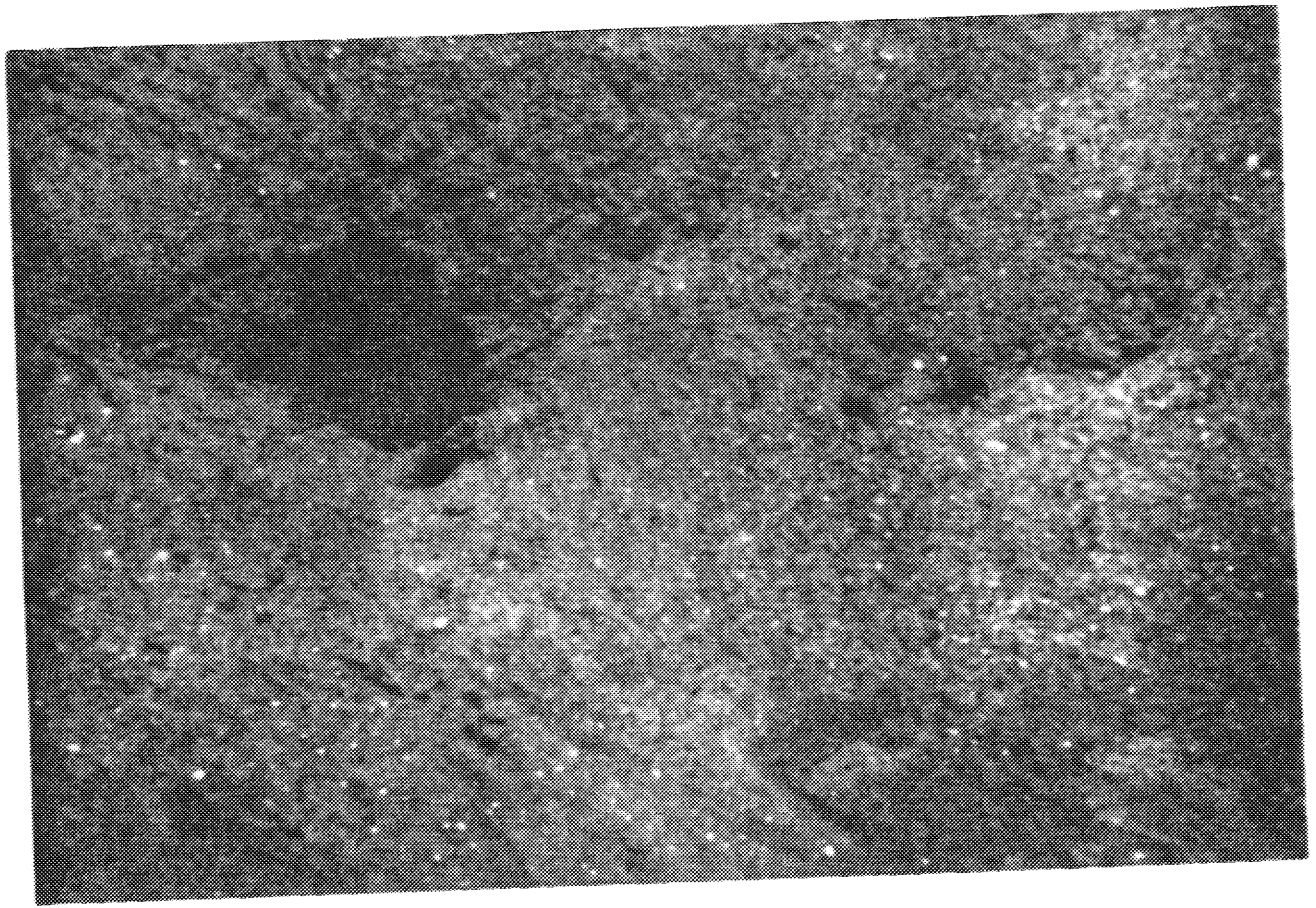
Figure 5.0-6a Pseudopleuronectes americanus winter flounder covered with natural bottom sediment, and several Urosalpinx on surface sediment (background).

Figure 5.0-6b Fourspot flounder (juvenile) utilizing soft sediment veneer adjacent to Norwalk spoil site.

e 5.0-6c Pipefish, Syrnathus fuscus, in resting state on soft sediment.

tle searobin, Prionotus (sp.) with caudal and pectoral
urried beneath soft surface sediment.

Figure 5.0-6e Pagurus demonstrating sediment feeding manipulation and bio-turbation zone.

is longicarpus on sediment/floculant patch area within
n sector.

Figure 5.0-6g Calico crab, Ovalipes (juvenile) photographed before complete burial beneath sediment.

Figure 5.0-6h Juvenile Lunatia leaves mucal track across sediment surface.

Figure 5.0-6i Polychaete Pectinaria cast contributes to sediment composition.

Figure 5.0-6j Cerianthus anemone within substrate with evidence of more consolidated sediment along border of tube. Note natural erosion troughs on either side of burrow tube.

Figure 5.0-6k Vertical burrow assumed to be representative of numerous Squilla type excavation in eastern Norwalk vicinity.

Photographs taken during the dives at the Norwalk Disposal Site are presented in Figure 5.0-6 (a-k).
